RECONNAISSANCE GEOPHYSICAL INVESTIGATIONS OF SALINIZATION
ALONG THE UPPER COLORADO RIVER (TMDL SEGMENT 1426),
COKE AND RUNNELS COUNTIES, TEXAS

Jeffrey G. Paine and Edward W. Collins
Bureau of Economic Geology
John A. and Katherine G. Jackson School of Geosciences
The University of Texas at Austin

Prepared for
Texas Commission on Environmental Quality
P.O. Box 13087
MC 150
Austin, Texas 78711-3087

September 2004

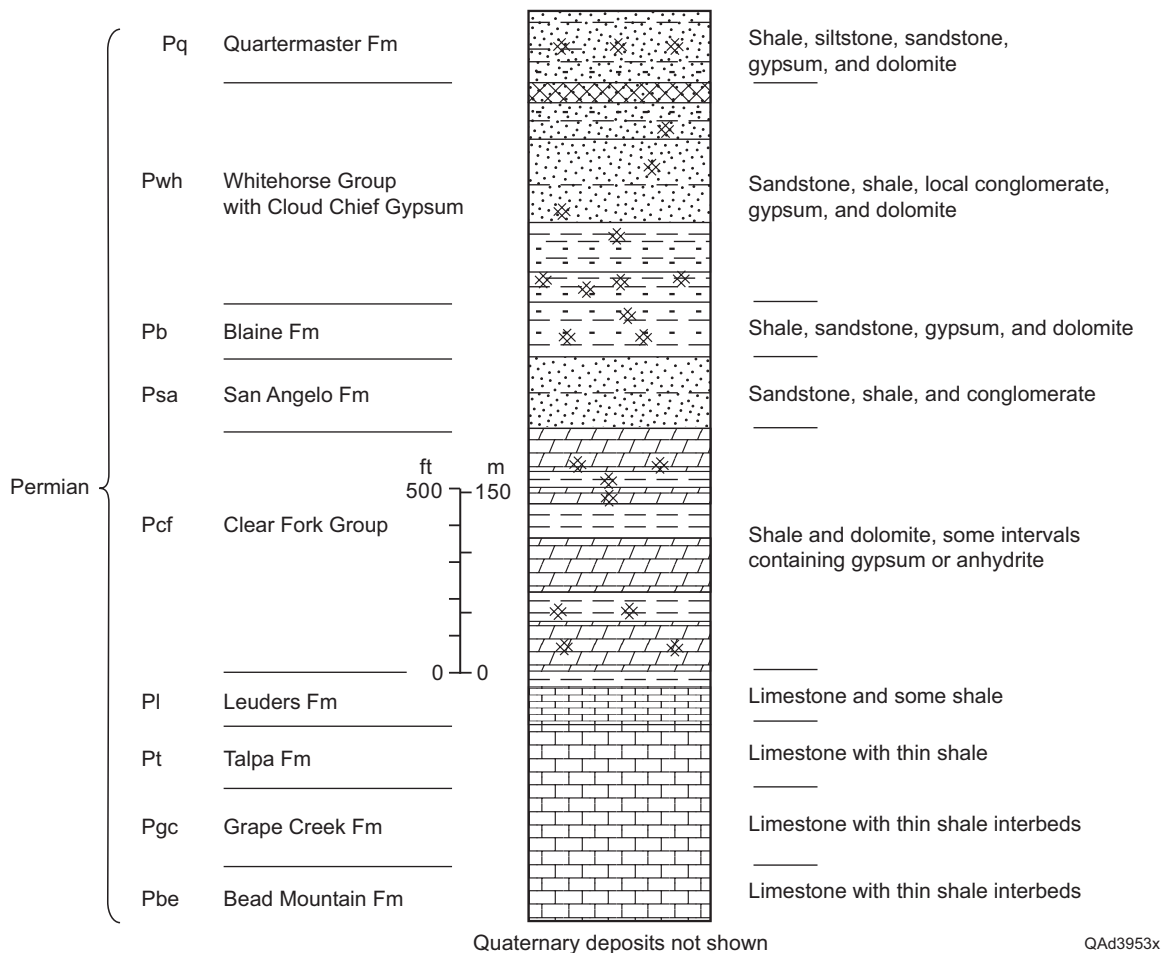
Figure 2. Generalized stratigraphic column and rock type for Permian units cropping out along the Colorado River in Coke and Runnels counties. Because these units dip regionally to the west, outcropping units become older in the downstream direction.

The Colorado River lies within a broad alluvial valley eroded into Permian stratigraphic units on the eastern flank of the Permian Basin (Eifler, 1975; Kier and others, 1976). The youngest bedrock units crop out in the Lake Spence area, including sandstones, shales, and dolomites of the Whitehorse Group and Quartermaster Formation. These units, as well as the underlying Blaine Formation shales, sandstones, and dolomite and the Clear Fork Group shales and dolomites that crop out between Robert Lee and Ballinger, include gypsum-bearing intervals whose dissolution likely contributes to degraded surface-water and ground-water quality in the area. Near and downstream from Ballinger, these evaporite-bearing strata are eroded away; geologic units at the surface in the southeast part of the study area are older Permian strata (Leuders, Talpa, Grape Creek, and Bead Mountain formations) composed dominantly of limestone with thin shale interbeds (fig. 2). Significant widths and thicknesses of unconsolidated to semiconsolidated Pleistocene and Holocene sand, gravel, silt, and clay have been deposited within the Colorado River alluvial valley. In some places, the bed of the river flows directly on Permian bedrock; in others, the river flows on a veneer of unconsolidated alluvial deposits.

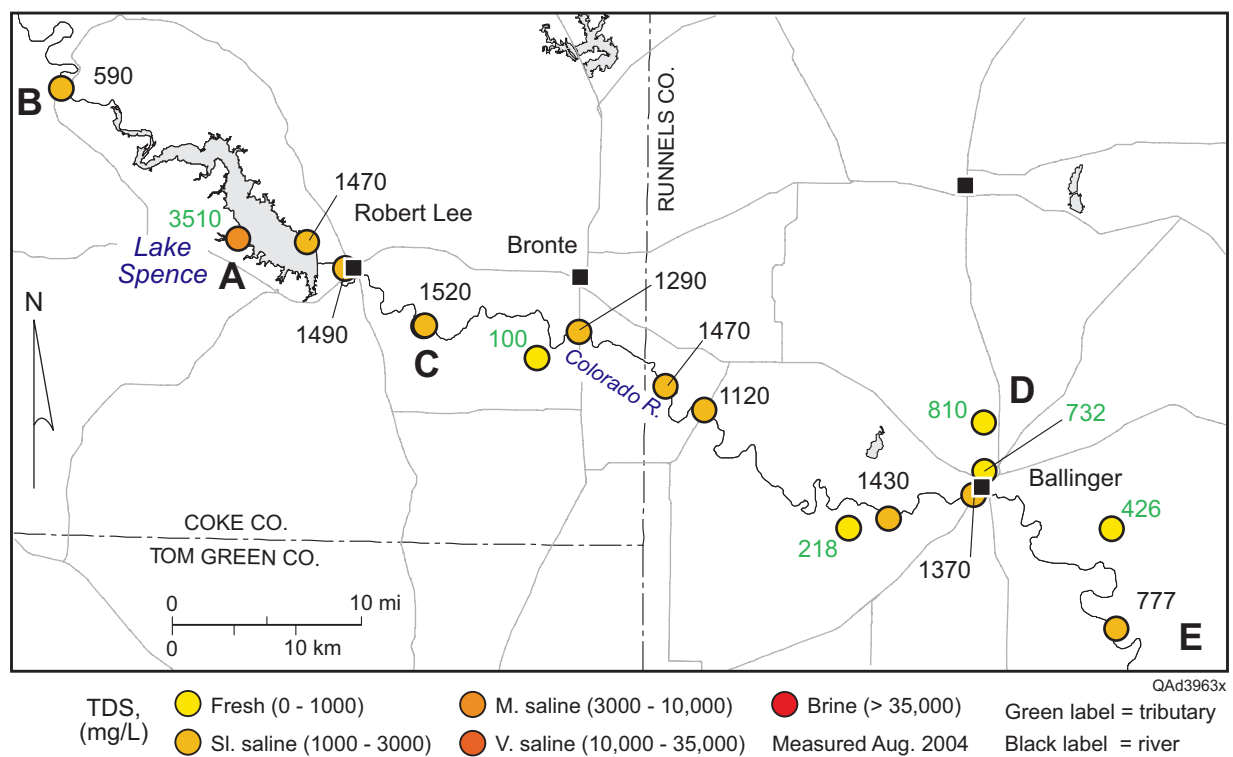
Figure 5. Map of the upper Colorado River segment 1426 study area depicting TDS concentration measured in August 2004 (appendix B).

We sampled flowing Colorado River water at nine locations downstream from Lake Spence (fig. 5; appendix B). Upstream from Ballinger (above the confluence with Elm Creek), measured TDS concentrations were similar to those measured in Lake Spence, ranging from 1120 mg/L at the FM 3115 bridge (fig. 5; location C194, appendix B) to 1520 mg/L near a gravel quarry where efflorescence was noted on alluvial deposits adjacent to the river (area C, fig. 5; location C191, appendix B). At Ballinger, Elm Creek contributed a significant amount of fresh water (732 to 810 mg/L TDS, fig. 5; locations C196 and C197, appendix B) to the Colorado River. Downstream from Ballinger at the Runnels County Road 129 bridge, Colorado River water was fresh at 777 mg/L (area E, fig. 5; location C206, appendix B).

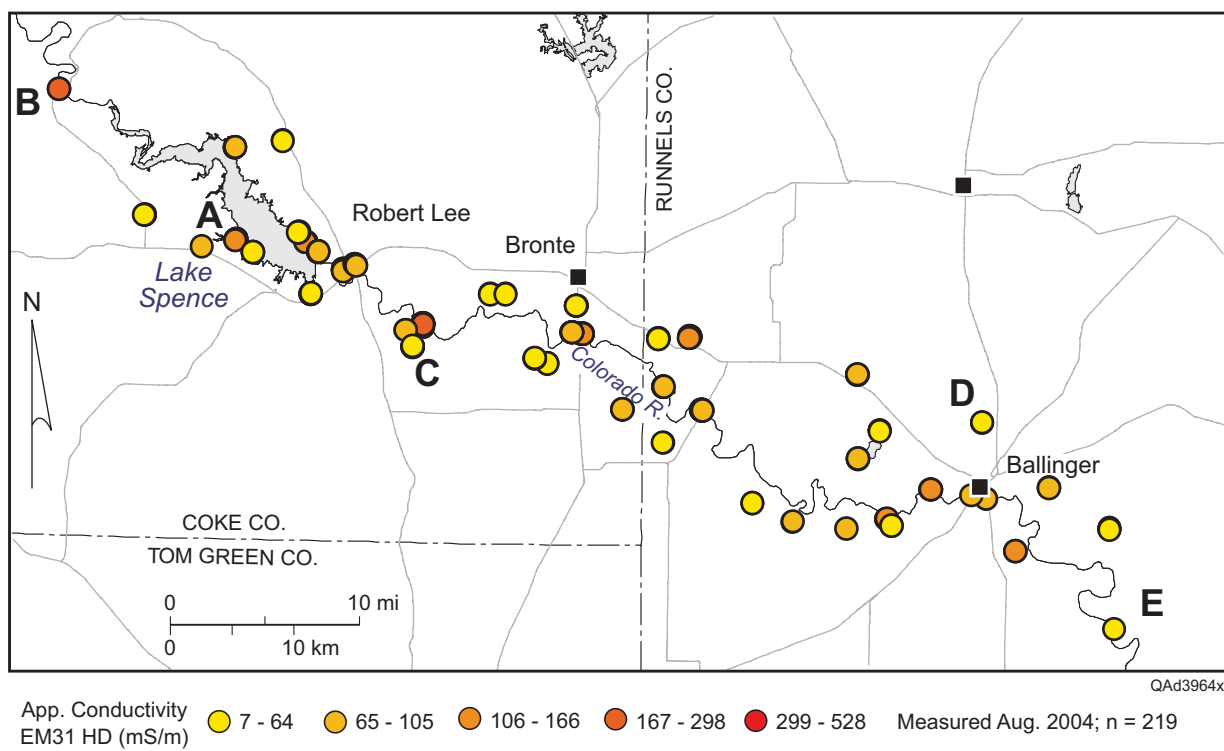
Figure 6. Apparent ground conductivity measured using an EM31 in the horizontal dipole (HD) mode.

In general, measured apparent ground conductivity is relatively low in this area. In the horizontal dipole (HD) instrument orientation, which measures apparent conductivity in the upper 3 m of the subsurface, measured values ranged from 7 to 528 millisiemens per meter (mS/m) and averaged 94 mS/m (table 1). A similar average (but lower maximum value) was obtained in the vertical dipole (VD) orientation, where the instrument explores to a depth of about 6 m (table 1).

We classified HD and VD apparent conductivities into five categories. HD values between 7 and 64 mS/m were considered low, 65 to 105 mS/m were low to moderate, 106 to 166 mS/m were moderate, 167 to 298 mS/m were moderate to high, and values of 299 mS/m and above were high (fig. 6). Slightly lower equivalent ranges were used for the VD measurements (fig. 7). Comparisons of the HD and VD values (appendix A) indicate they are highly correlated such that sites with high HD values also had high VD values. Despite the limited access to the river and its tributaries, we recorded elevated conductivities at several sites that are consistent with near-surface salinization that may contribute to degraded Colorado River water quality.

Moderate to high apparent conductivities were recorded along Salt Creek at the Paint Creek Recreation Area (area A, figs. 6 and 7; locations C028 to C039, appendix A). An apparent conductivity profile along the stream (figs. 8 and 9) depicts elevated conductivities ranging from 122 to 192 mS/m in the shallower HD orientation and 71 to 116 mS/m in the deeper VD mode, suggesting surface salinization associated with evaporative concentration or the presence of contributing salinity sources farther upstream. Surface water at this location was moderately saline in August 2004 (fig. 5).

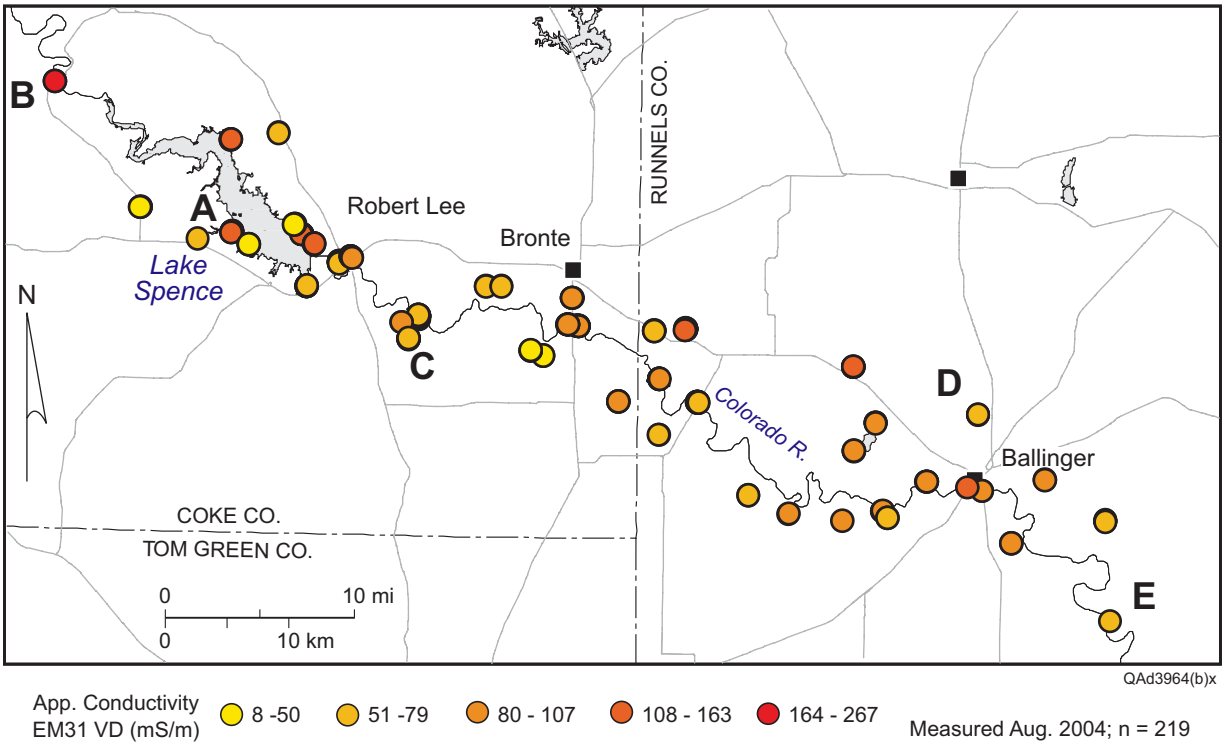
Figure 7. Apparent ground conductivity measured using an EM31 in the vertical dipole (VD) mode.

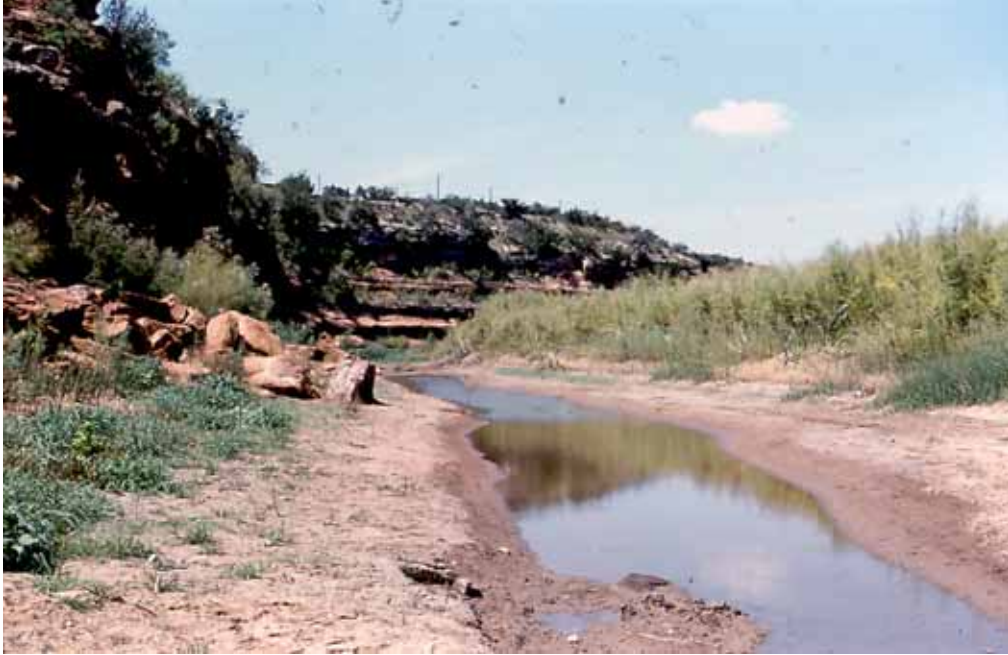
Figure 8. Photograph looking upstream along Salt Creek at Lake Spence.

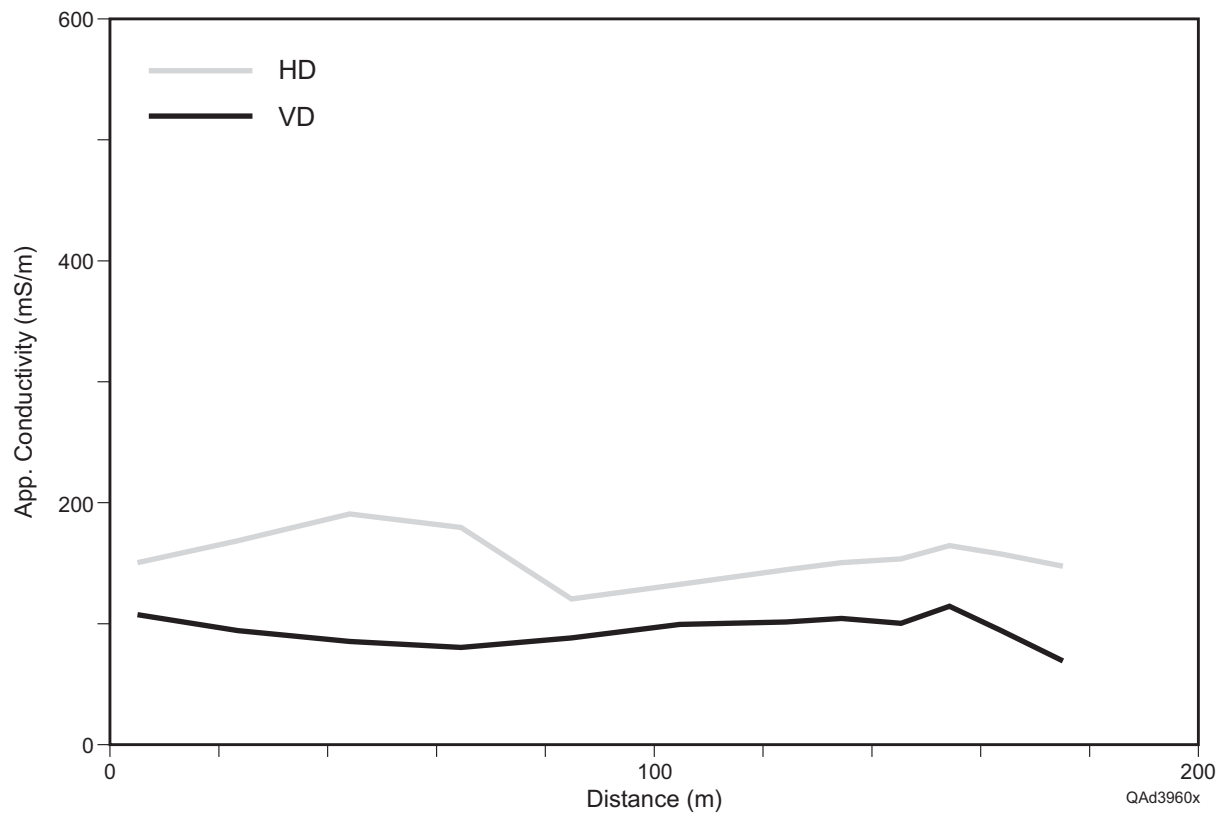
Figure 9. Apparent ground conductivity profile downstream along Salt Creek at Lake Spence.

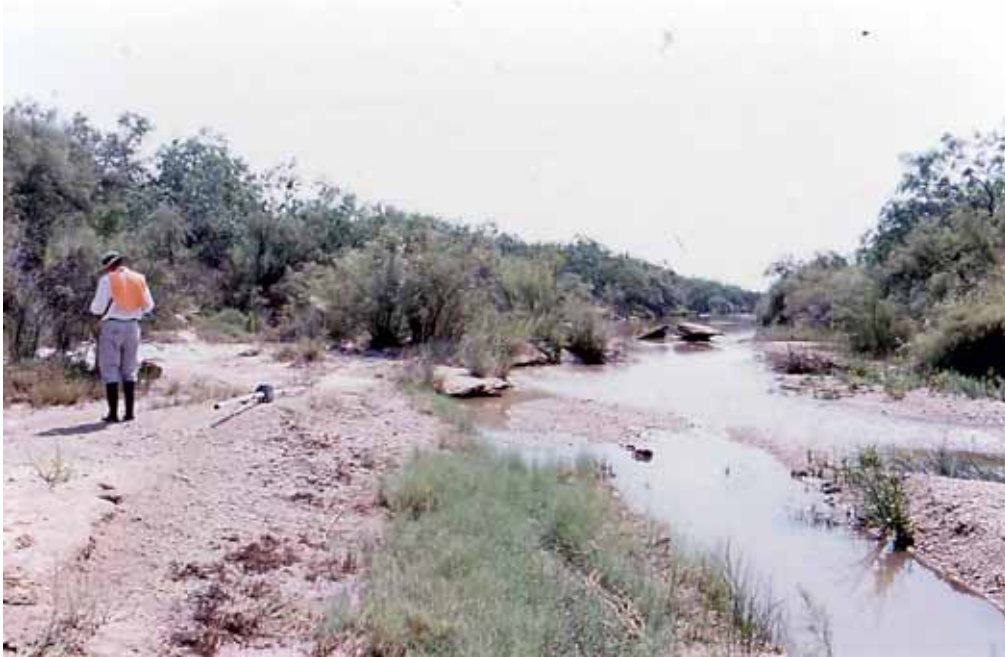
Figure 10. Photograph of efflorescence on the bank of the Colorado River in a saltwater seep area near Machae Creek.

Possible sources of salinity in this area include natural discharge of saline groundwater and nearby oilfield-related discharge.

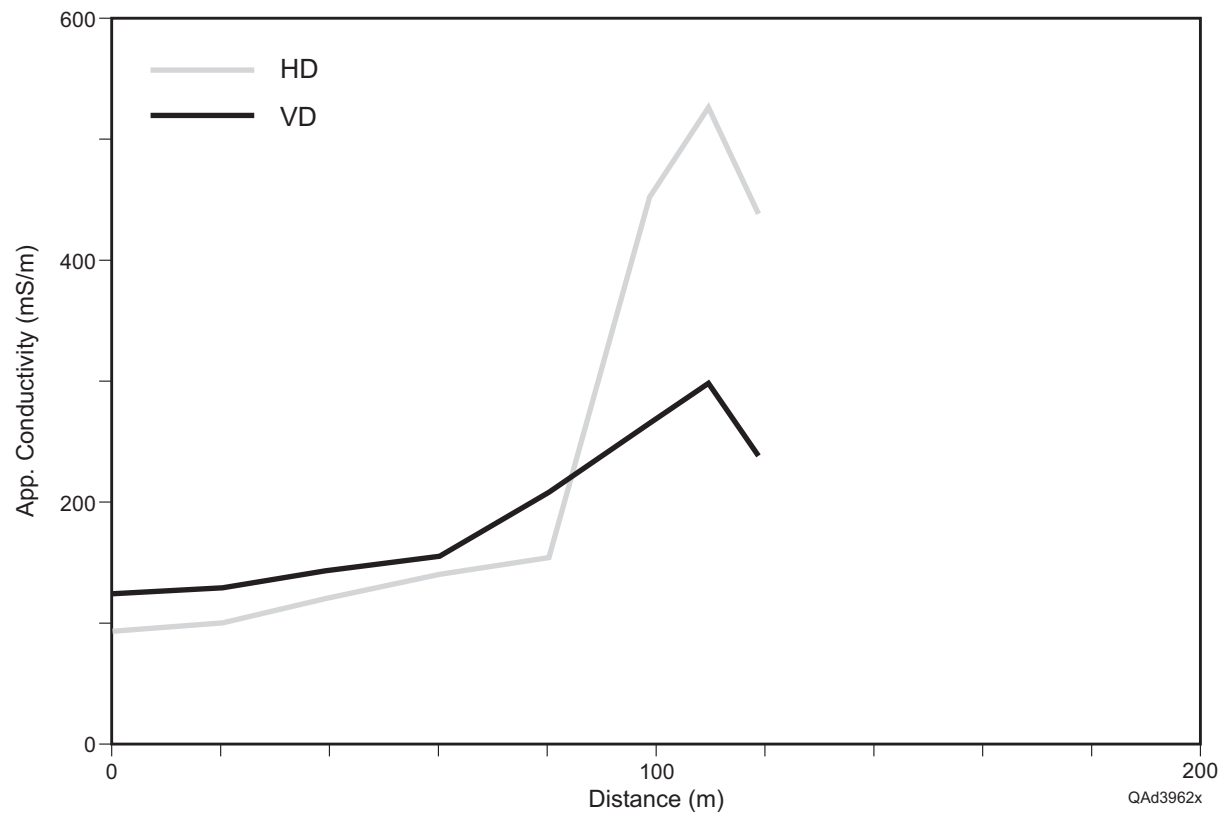
Figure 11. Apparent ground conductivity profile downstream along the Colorado River near Machae Creek.

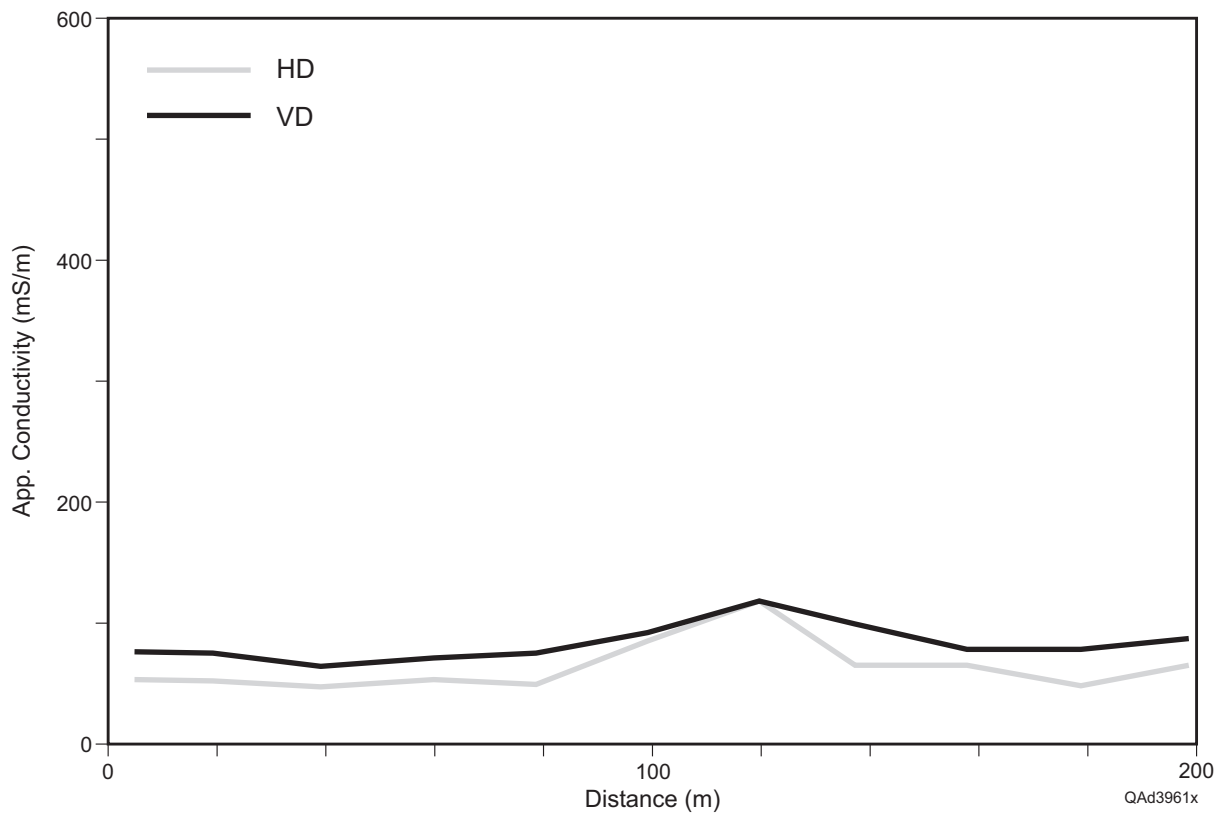
Figure 12. Apparent ground conductivity profile downstream along Mountain Creek (dry) at Robert Lee.

A short segment along the dry stream bed of Mountain Creek near Robert Lee also exceeded 100 mS/m (fig. 12). Relatively low peaks such as these that extend only a short distance along a stream bed are unlikely to represent major salinity sources.

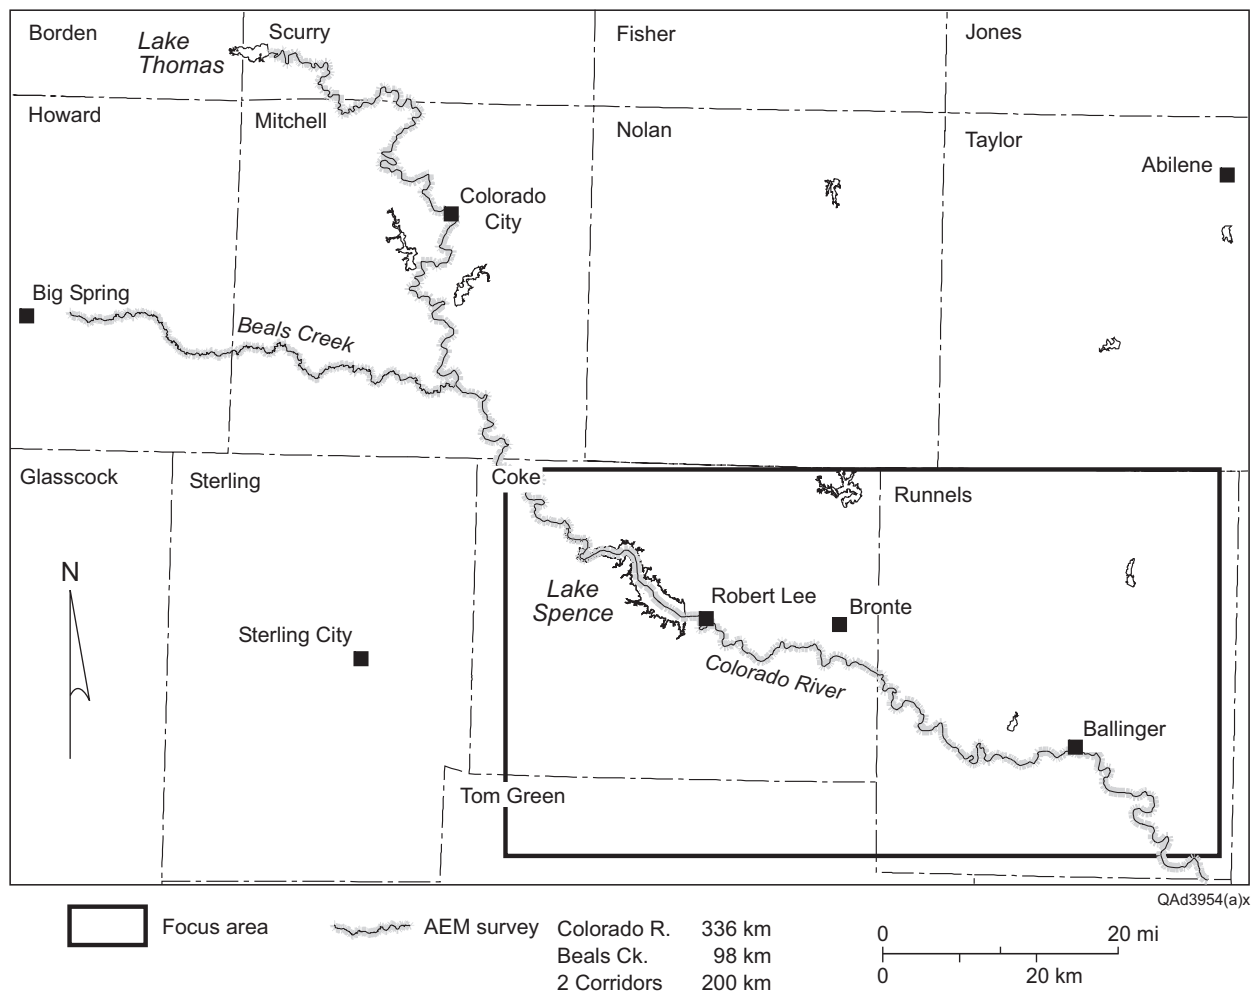
Figure 13. Recommended airborne geophysical survey route along the axis of the Colorado River from Lake Thomas to below Ballinger and along Beals Creek from Big Spring to the Colorado River confluence.

Limited access to the Colorado River and its tributaries by foot, public road, or watercraft precludes a comprehensive assessment of potentially salinized segments of the river below Lake Spence. Where there was access to the river, local areas of elevated conductivity and relatively high TDS water were identified, such as the area near Machae Creek downstream from Robert Lee. In addition, the presence of relatively high salinity water in Lake Spence and likely natural and oilfield sources of salinity upstream from Lake Spence, including along significant tributaries such as Beals Creek (Sullivan and others, 1999) suggests that the most efficient next step would be to conduct a reconnaissance airborne geophysical survey of the area. Rather than fly a gridded survey over the entire area of interest that would be prohibitively expensive, we recommend an innovative approach in which a low-flying helicopter would carry a multi-frequency EM conductivity meter along the axis of the Colorado River along the entire length of segment 1426. Because there are significant salinity sources upstream from Lake Spence that impact Colorado River water quality in segment 1426, the river-axis survey could be extended farther upstream to Lake Thomas and along Beals Creek from near Big Spring to its confluence with the Colorado River (fig. 13).

Total Colorado River and Beals Creek flying distance is estimated to be 434 km, including 336 km along the Colorado River from Lake Thomas to the southeast corner of Runnels County and 98 km along Beals Creek upstream from its confluence with the Colorado River. In addition, 200 flight km

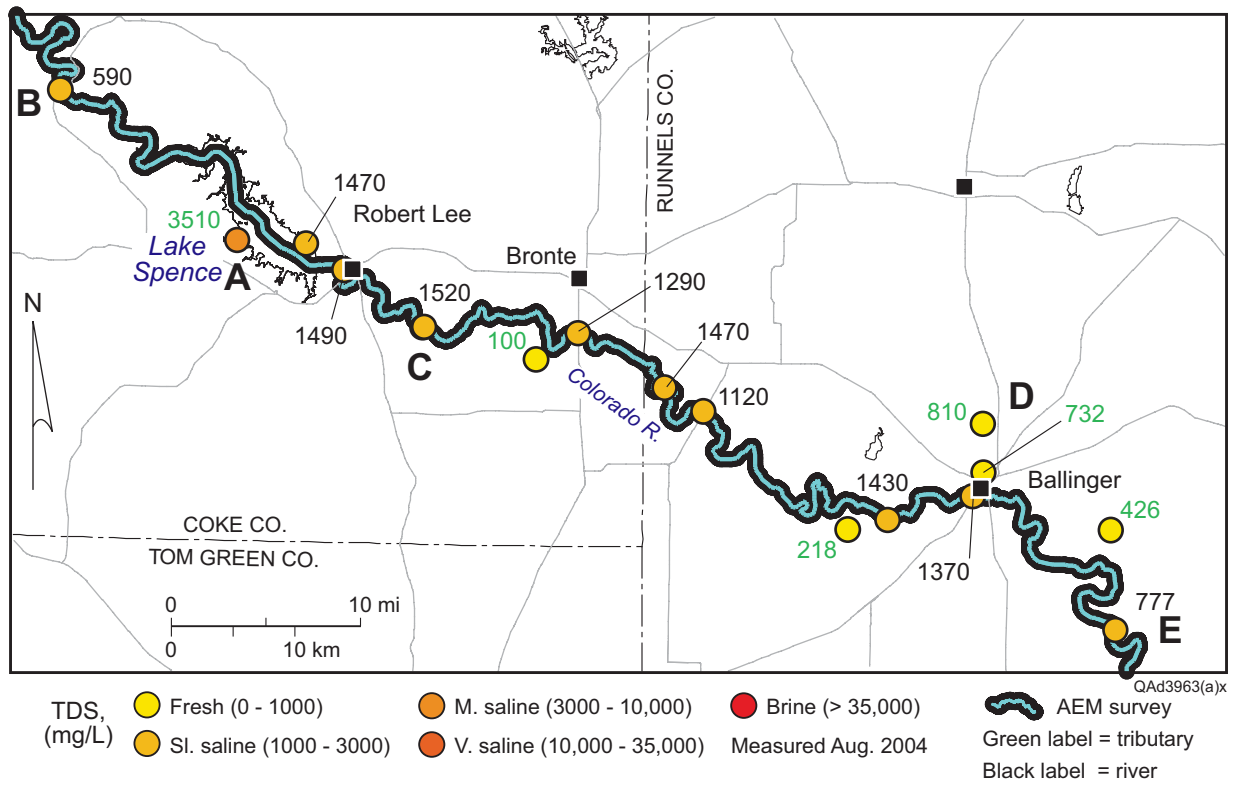
Figure 14. August 2004 TDS concentrations superimposed on part of the recommended airborne geophysical survey route along TMDL segment 1426.

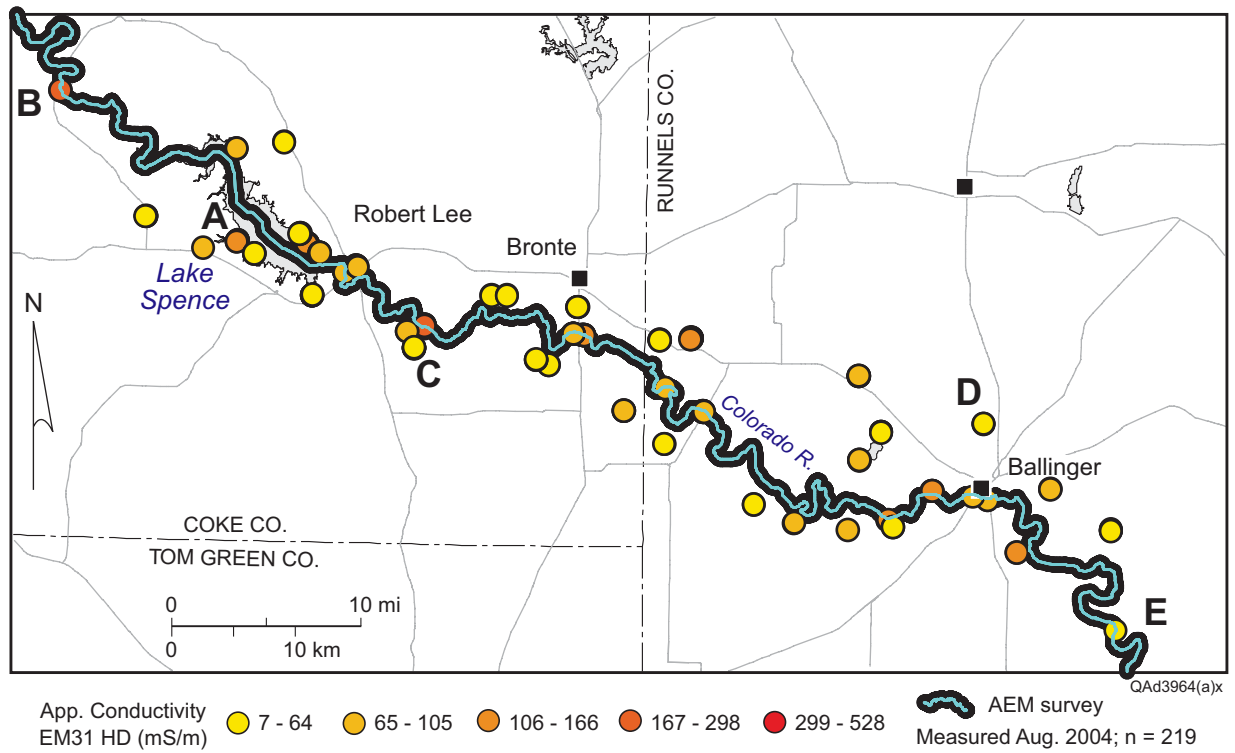
Figure 15. Apparent ground conductivity measurements superimposed on part of the recommended airborne geophysical survey route along TMDL segment 1426.
